## PHASE CHEMISTRY OF DIGOUT SAMPLES FROM A FERROSILICON FURNACE

<sup>1</sup>J. Nell, <sup>2</sup>C. Joubert

### ABSTRACT

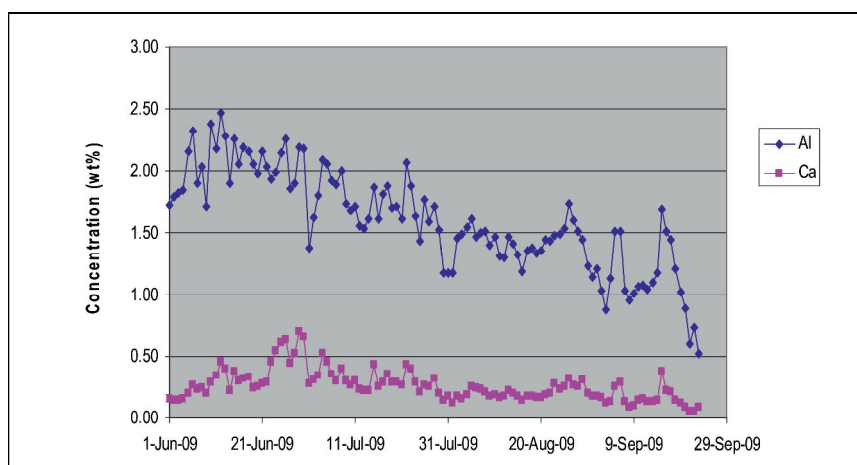
Siltech noticed gradual changes in the performance of furnace B over a period of almost 3 months leading up to the September 2009 tapping problems. The systematic decrease in the aluminium content of the hot metal was particularly profound (figure 1) and was mirrored by the metal-to-slag ratio (figure 2). At the resolution of the data the SEC did at first not significantly increase but from September 2009 it trended above 10 MWh/t metal (figure 3).

**Figure 1:** Aluminium and calcium in hot metal from Furnace B for the period 1 June to 23 September 2009

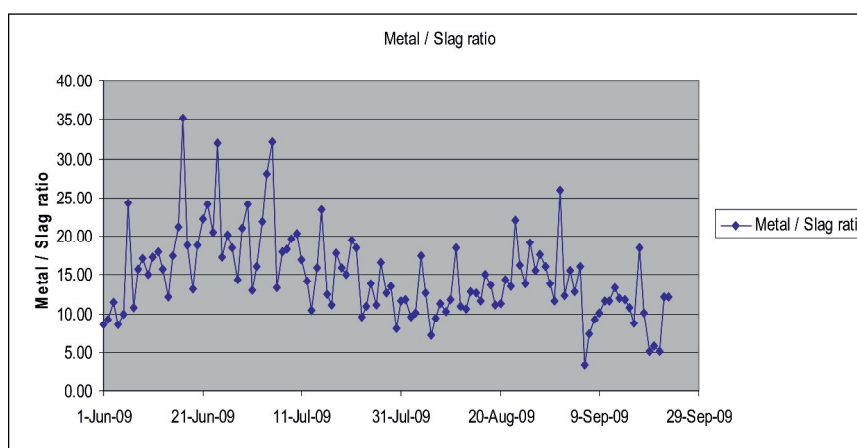
**Figure 2:** Metal-to-slag ratio over the period 1 June to 23 September 2009

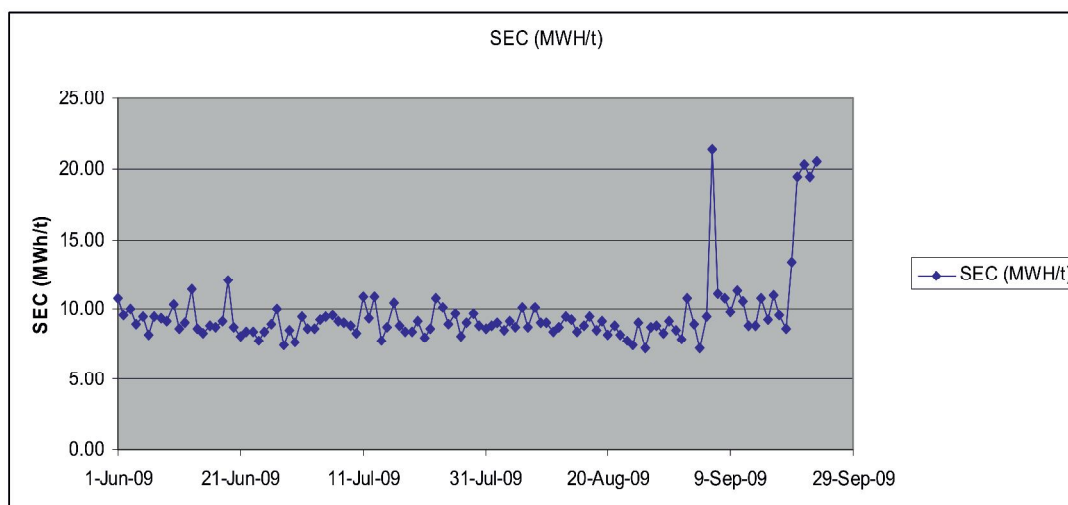
**Figure 3:** SEC over the period 1 June to 23 September 2009

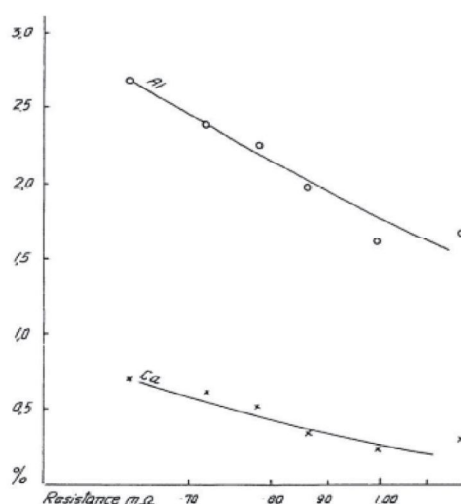
The trends in metal composition and metal-to-slag ratio are indicative of lower temperatures in the active reduction zone in the electrode craters and would normally be associated with an

increase in electrode resistance (figure 4) [1]. Because the Siltech furnaces are operated under resistance control the electrode immersion must have decreased to maintain the resistance setpoint of about 0.93 mΩ.

**Figure 4:** Relationship between metal composition and electrode resistance in high-grade ferrosilicon [1]

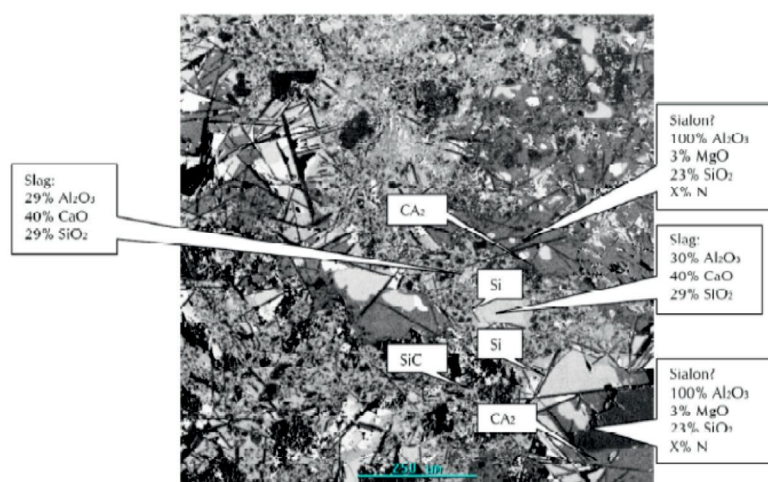
**Figure 5:** Backscattered electron image illustrating silicon being replaced by  $\text{CA}_2$  or slag, as well as sialon platelets in a matrix of slag and  $\text{SiC}$ . Sialon is characterised by the absence of Ca and the presence of Mg and N (in the sialon analysis all elements are arbitrarily expressed as oxides).

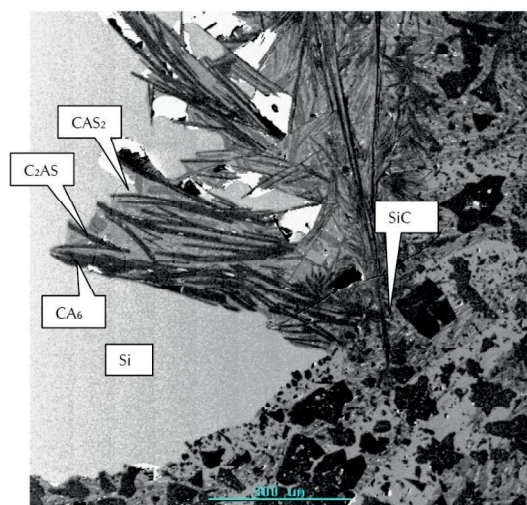
Striking examples of slag alteration and localized variability are found around droplets of silicon that are being ‘replaced’ by slag that predominantly comprises  $\text{CA}_6$  or  $\text{Al}_2\text{O}_3$  (figure 6 and figure 7). It is postulated that these replacement textures are the result of  $\text{SiO}$  generation from the slag according to the following reaction:

**Figure 6:** Backscattered electron image illustrating the replacement of Si by CA<sub>6</sub>, C<sub>2</sub>AS and CAS<sub>2</sub>

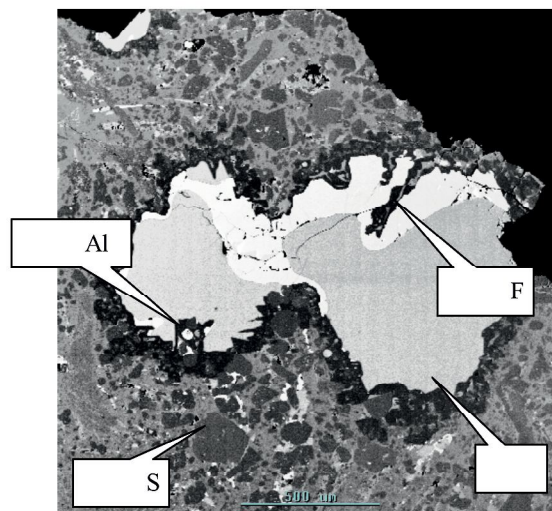
**Figure 7:** Backscattered electron image of Al<sub>2</sub>O<sub>3</sub> (corundum) crystals surrounding metal droplets. The resorbed appearance of the Si suggests that it is being replaced by corundum

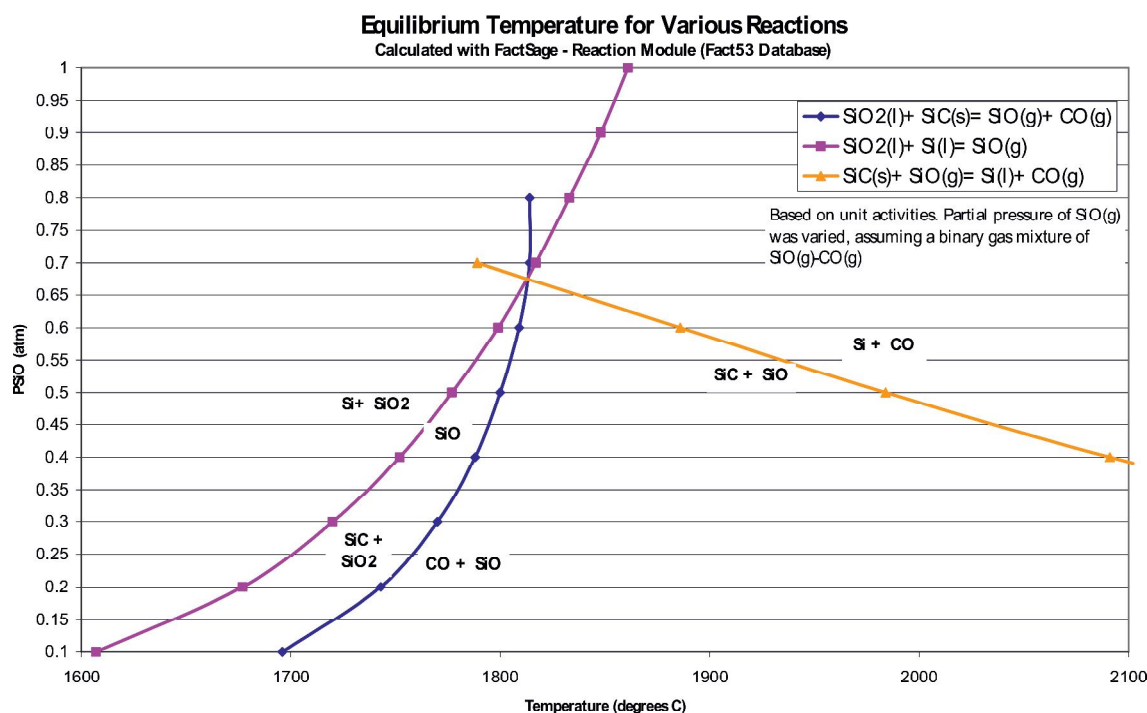
which is equivalent to the reaction  $\text{Si} + \text{SiO}_2 = 2\text{SiO}$  in the Si-O system. The reaction is favoured by low partial pressures of SiO (figure 8). In the presence of SiC, SiO<sub>2</sub> will oxidize Si at temperatures below about 1800°C (at higher temperatures the reaction  $\text{SiO} + \text{SiC} = \text{Si} + \text{CO}$  will stabilize Si).

**Figure 8:** Subset of univariant reactions in the system Si, C and O. The reaction  $\text{Si} + \text{SiO}_2 = 2\text{SiO}$  (pink curve) may explain the replacement of Si droplets by alumina-rich slag. At temperatures below about 1800°C (the temperature of the invariant point), SiO released by the reaction  $\text{Si} + \text{SiO}_2 = 2\text{SiO}$  will not be able to react with SiC

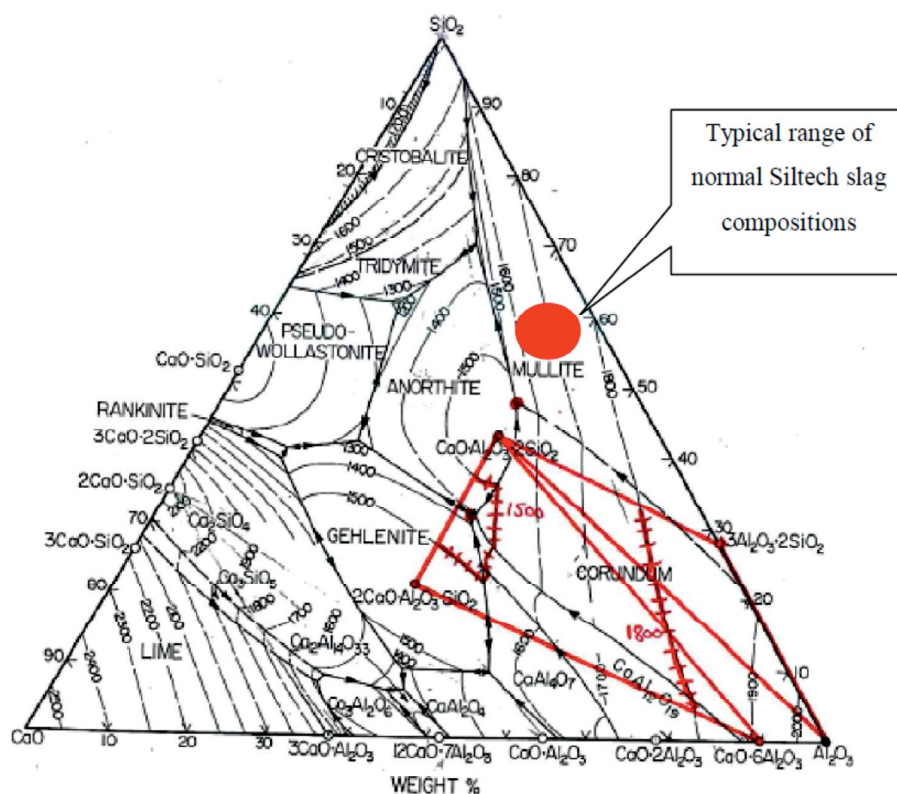
The solidus triangles defining the  $\text{SiO}_2$ -depleted oxide phase assemblages are outlined in figure 9. It is immediately evident that the samples are significantly enriched in alumina relative to typical furnace slag that would run at about 70%  $\text{SiO}_2$ . The equilibrium solidus temperatures of the phase assemblages are in the range of 1400 to  $1500^\circ\text{C}$ . Liquidus temperatures in those parts of the samples containing  $\text{CA}_6$  and  $\text{Al}_2\text{O}_3$  may be as high as 1900 to  $2000^\circ\text{C}$ .

**Figure 9:** Phase diagram of the system  $\text{SiO}_2$ - $\text{CaO}$ - $\text{Al}_2\text{O}_3$ . The solidus triangles defining the  $\text{SiO}_2$ -depleted phase assemblages are highlighted in red. The solidus temperatures of the invariant assemblages are marked by dots. The  $1500^\circ\text{C}$  and  $1800^\circ\text{C}$  liquidus isotherms are marked to provide a sense of liquidus temperatures for the oxide assemblages

The phase chemical data for the samples clearly indicate that apart from the presence of highly refractory SiC, the high alumina content of the banks served to significantly increase the liquidus temperature, especially where localised formation of  $\text{CA}_6$ ,  $\text{Al}_2\text{O}_3$  and sialon had taken place.
