**DAMAGE CAUSED BY THE EAST JAPAN EARTHQUAKE  
AND RECOVERY FROM THIS DISASTER  
AT THE KASHIMA WORKS, CHUO DENKI KOGYO CO., LTD**

**ABSTRACT**

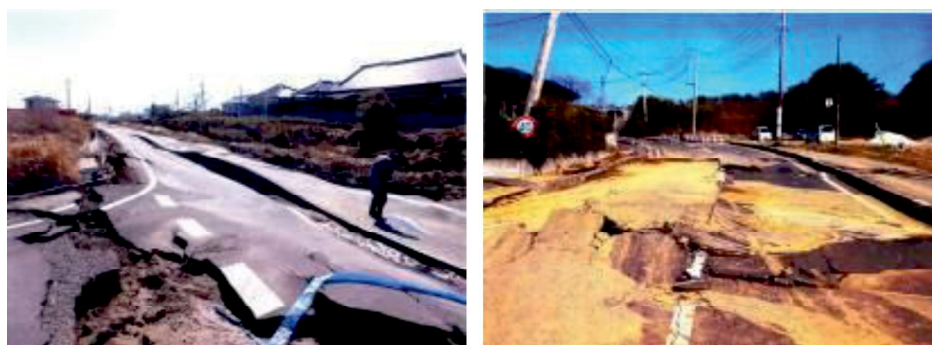
**Figure 3.1.1:** Uplift and caving-in caused by liquefaction

Figure 3.1.1 shows the uplift and caving-in caused by the liquefaction of the ground beneath the road. Figure 3.1.2 shows how roof tiles were dislodged from houses and how concrete block walls crumbled. Figure 3.1.3 shows the damage caused by the tsunami at Kashima port (near our facility). Many shipping containers located near the port were swept away by the tsunami.

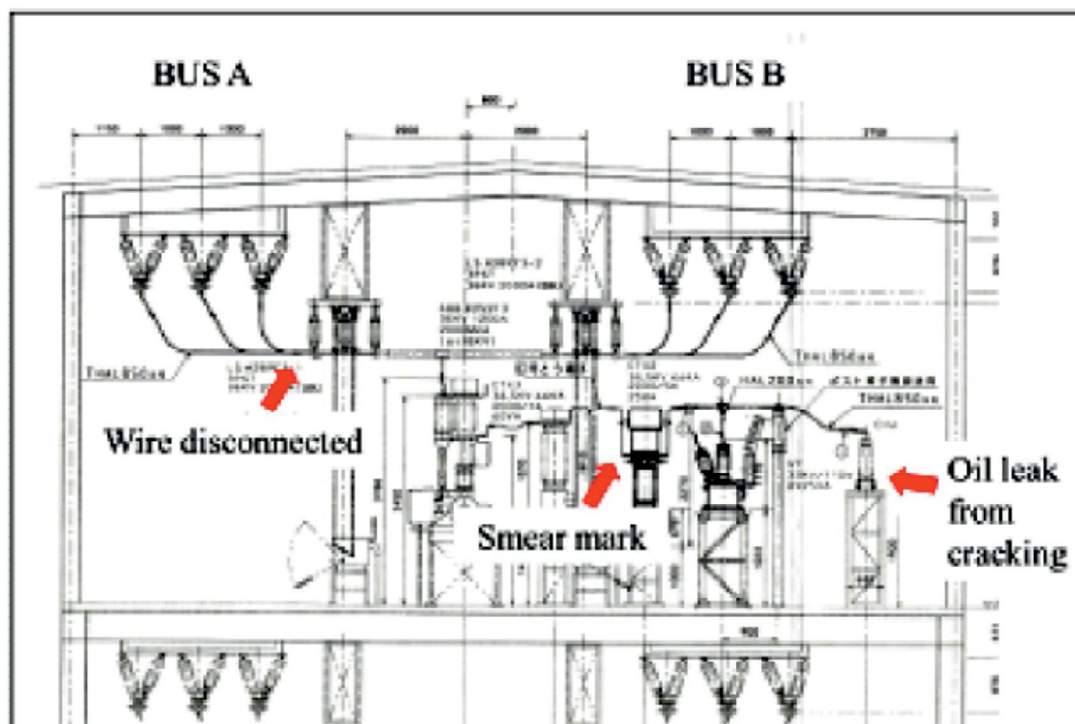
Figure 4.1.2: Damages of the electrical transmission facility at central electrical substation

Figure 4.1.2 shows extensive damage to the electrical transmission facility at the central electrical substation.

The electrical transmission facilities of KF-1 are located on the 2nd floor of a two-story building. During the quake, a load of nearly 500 ~1500 kg (stress) was exerted on the terminal area and the material structure of this equipment via the connected conductors.

This caused the connecting wires to disconnect, breaking the switch and allowing the dielectric oil in the insulator of the OF cable to leak out.

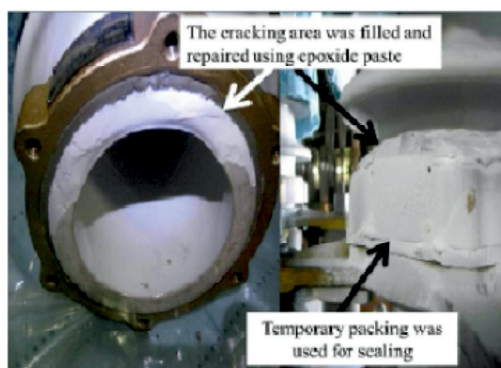
**Figure 4.1.3:** OF cable insulator

Figure 4.1.3 shows how restoration work was carried out. The broken insulator was found to have been caused by the lack of a seating face and the cracking of the joint connecting the metal flange and the insulator. The cracking area was filled using an epoxide paste with a high electrical insulation rating and temporary packing was used to repair the sealing area.

These problems were all repaired within two weeks. At the end of April, we exchanged the temporary insulator for the correct type of insulator and analyzed the oil in the transformers to confirm that all was normal.

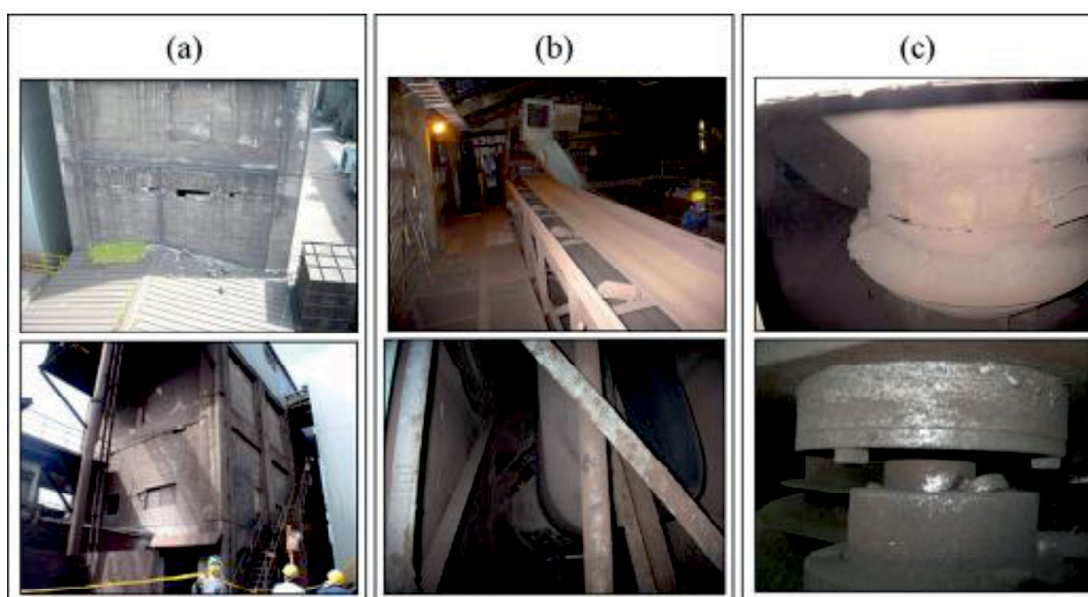
**Figure 4.3.1:** The damage of (a) outer wall of material storage tank, (b) raw materials conveyor, (c) bin above the material furnace

In figure 4.3.1, the upper left-hand picture shows the partially collapsed wall of the material storage area, while the middle picture shows the derailment of a truck on a raw materials conveyor belt. The right-hand pictures in figure 4.3.1 show cracking in the cushion of the bin above the furnace and damage to the load detection device.

Figure 4.3.1 ~ 4.3.3 shows the damage to various items of equipment. We decided to repair these in order of priority, as necessary, to restart operation of the furnaces.

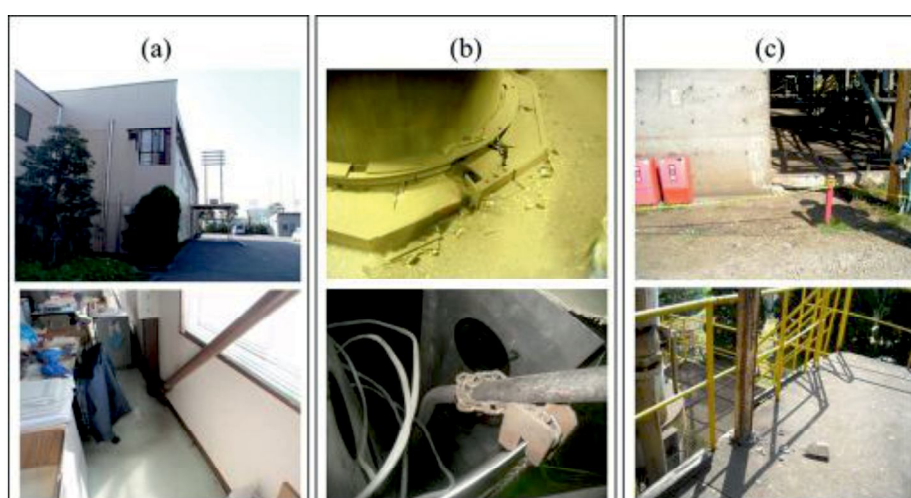
**Figure 4.3.2:** The damage of (a) office building, (b) Electrode facility, (c) gas facility

In figure 4.3.2, the left-hand pictures show the partially collapsed outer wall of the office and the broken braces inside. The middle pictures show the damage caused to the insulation around the electrodes and deformation of the supporting pipe used to measure the temperature at the center of the electrode. The right-hand pictures show uneven subsidence around the base of the gas facilities.

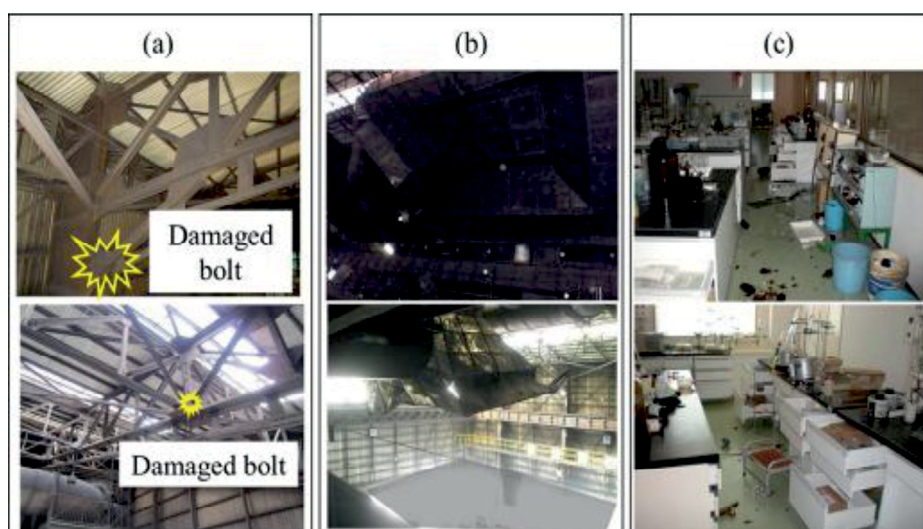
**Figure 4.3.3:** The damage of (a) KF-1 roof truss, (b) dust-catching hood, (c) analytical laboratory

In figure 4.3.3, the left-hand pictures show the damaged bolts supporting the bracing in the furnace building. The middle pictures show the deformation of the dust-catching hood, while the right-hand pictures show the analytical laboratory after the quake.
