The design and development of furnace linings for manganese alloys smelting.

N J van der Walt  
General Works Manager  
Tubatse Ferrochrome  
P O Box 46  
Steelpoort - 1133  
Republic of South Africa

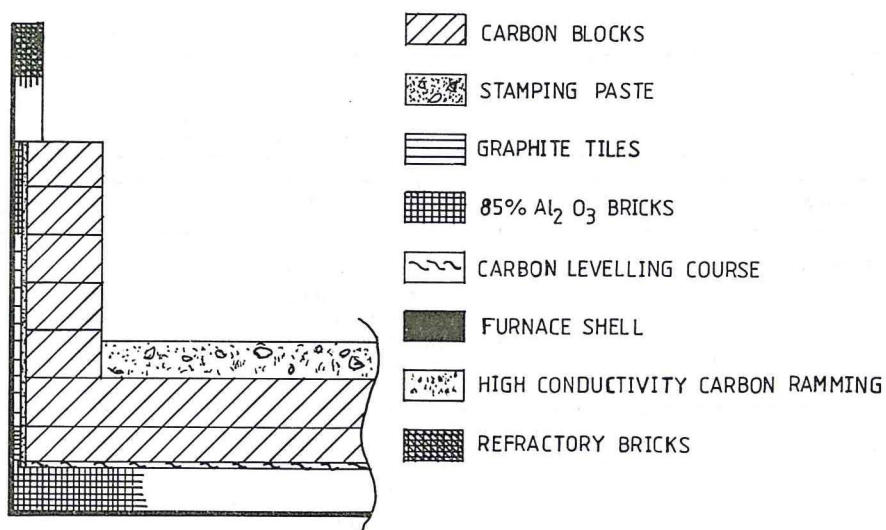
FIG. II

All linings installed prior to November 1980 were of a design which had a low thermal conductivity. This design is shown in figure 1. The overall thermal conductivity of the lining installed in M12 furnace during 1981 was increased and the thickness of the carbon lining was increased at the expense of the refractory bricks. However, one layer of refractory bricks was kept as a backlining. In the subsequent lining installation on M10 and M11 this principle was taken one step further when the refractory bricks were replaced with graphite tiles in the area where the risk was the highest for a hot metal break-out. This design is shown in figure II.

lining. At that point it was unknown whether the higher conductivity lining would have the desired effect on lining life. This proved to be a further improvement, although the furnace tend to be "cold" and tapping problems are sometimes experienced.

| Figure II | Schematic drawing of new design lining |

Figures III and IV show a comparison of temperature profiles between the 2 lining designs which were discussed in section 5. Figure III indicates temperature profile for the former lining (pre-1980) [compare figure 1] while Figure IV indicates the temperature profile for the new lining design with graphite tiles. [Compare figure II].

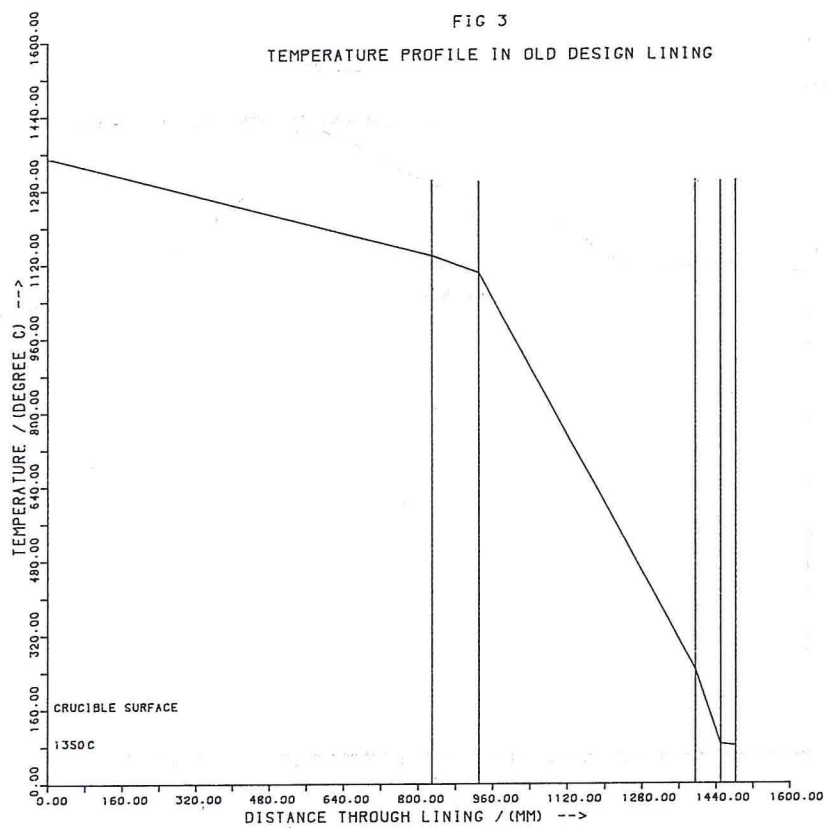
It can be seen that with the new designs the lower temperature isotherms are shifted deeper into the furnace, thus resulting in lower lining temperatures.

| Figure III | Temperature profile in old design lining |

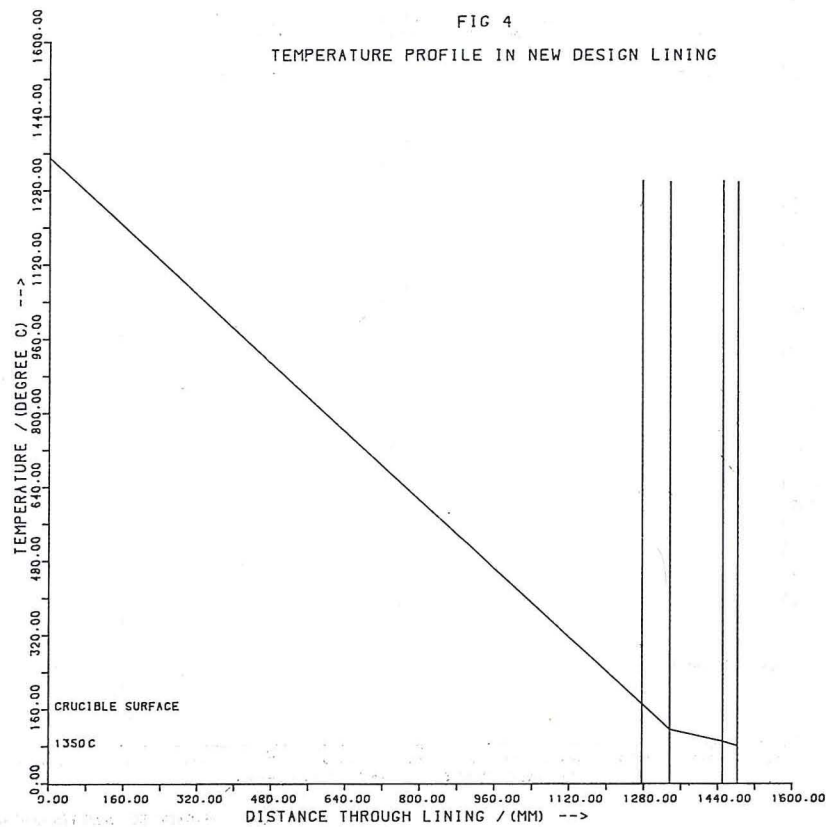
| Figure IV | Temperature profile in new design lining |

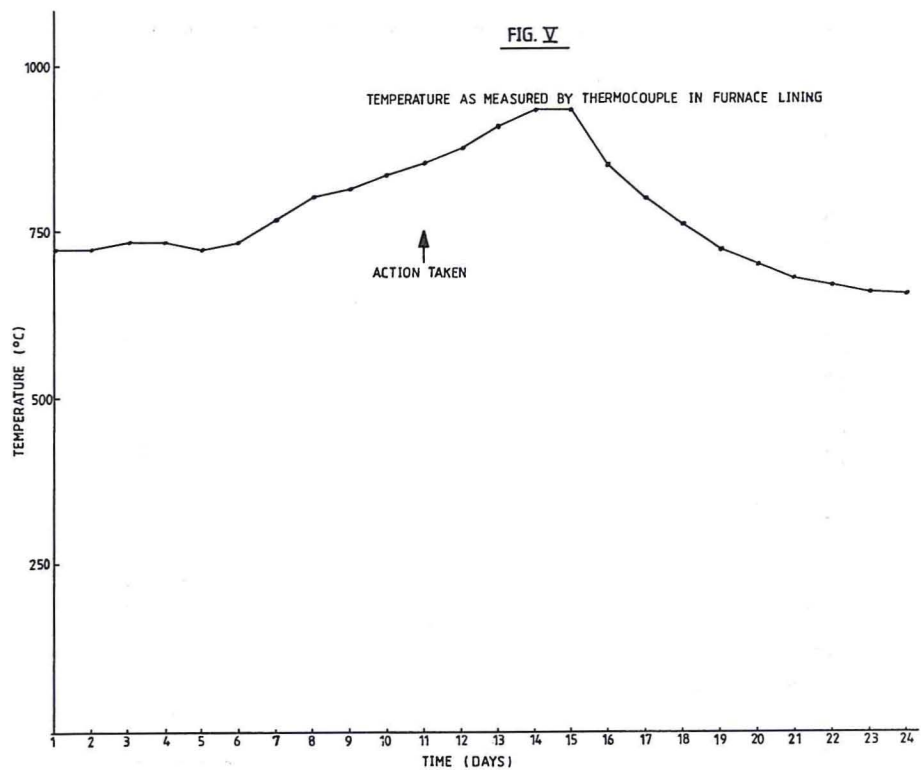
During August 1982 a sudden increase in lining temperature was observed on M12 furnace. The increase in temperature was noticeable on all the side wall thermocouples but the rate of increase was higher opposite one of the electrodes. Simultaneously it was observed that the opening depth of the tapholes was shorter i.e. the distance to which a taphole was drilled before the slag or metal started to flow.

This was a very alarming situation as the temperature increased at a rate of 25°C per day and it was clear that if the trend were to continue, a hot metal break-out would occur within a few days. The temperature as recorded by one of the thermocouples in the side wall opposite the electrode is shown in figure V.

| Figure V | Temperature measured by a thermocouple in the furnace lining. |

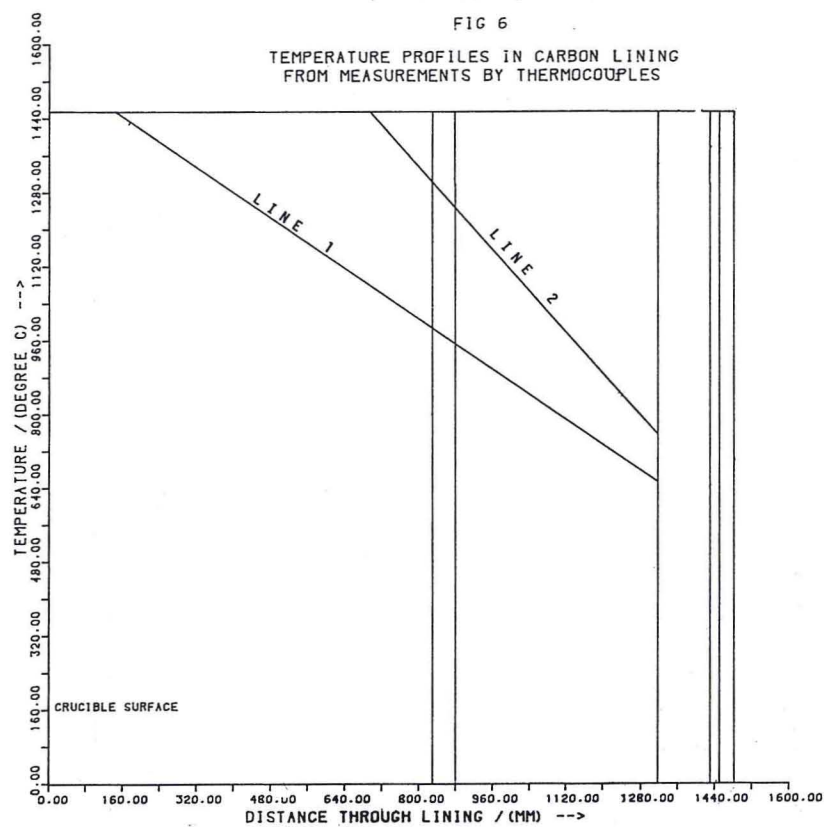
A temperature profile was drawn to indicate the changes in isotherms in the lining during the temperature increase. This was done by joining two temperature points as measured by two

thermocouples at different depths in the lining and extrapolating the line. This is schematically shown in figure VI. Line 1 is the temperature profile before the increase in temperature and line 2 is the temperature profile when the temperature was at a peak. During this period the workface temperature of 1 450°C moved 550 mm deeper into the lining which represents 38% of the total thickness of the lining. This resulted in a higher lining temperature and presumably a significant portion of the lining was eroded away. As a result of the action taken as described above, the process of erosion was stopped and the resulting lining temperature was lower than it was before the problem started.

| Figure VI | Temperature profiles in carbon lining from measurements by thermocouples. |
