## **TEMCO F1 operation on freeze lining 2001–2017**

**S. Pal<sup>1</sup> and G. Ciezki**

<sup>1</sup>South 32, George Town, Australia

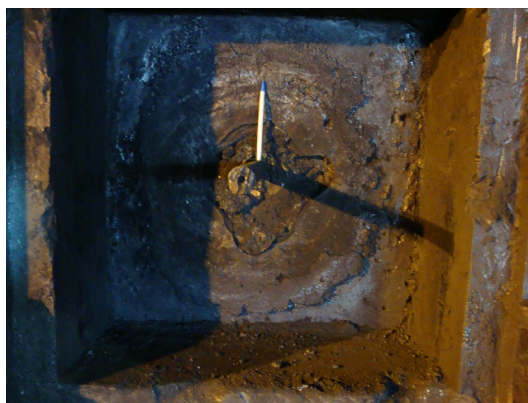
**Figure 14:** Tap-hole condition observed during TPS-2012 (after 11 years of service)

Since relining Furnace 1 in 2001, the tap-holes used on Furnace 1 have not had any major repair or replacement to date. Tap-hole condition is shown in Figure 14 after 11 years of operation. The tap-hole is generally drilled open, and an oxygen pipe is used only after extended shutdowns or opening a new tap-hole. The maintenance of drills and mud guns is considered very important to ensure that a good quantity of tap-hole mud is pumped into the tap-hole cavity when plugging the furnace. A steel plate is used on the front of the hole to make a good contact for the mud-gun nozzle, and is replaced when it begins to warp from exposure to high temperatures.

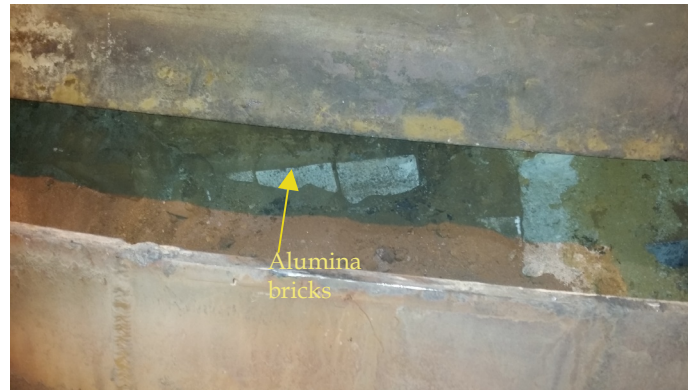
**Figure 15:** Brick removal from Furnace 1

- In tap-hole regions, it has been seen that thermocouples have become increasingly more difficult to extract from the lining when requiring replacement.
- The upward movement of alumina bricks from inside the furnace crucible has caused significant lifting of the furnace cover. A total of ten rows of alumina bricks have been removed from the front of the furnace mainly, but also from the scrubber offtake adjacent area. This is believed to be due to the process slag replacement of the sacrificial face bricks installed on the inside of the furnace.

These bricks do not show chemical attack or change in original dimensions (see Figure 15).

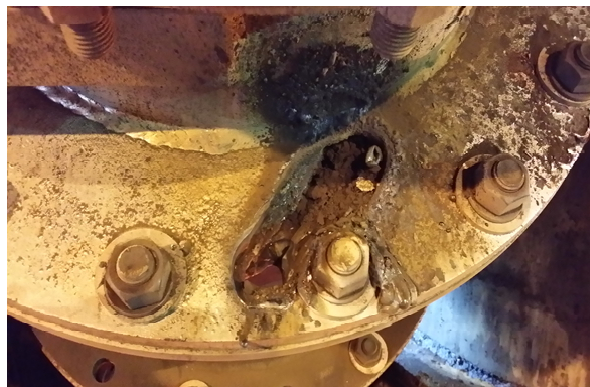
**Figure 16:** Arcing of feed chute due to material leakage

The extended life of the furnace caused some maintenance issues, such as maintenance of feed chutes, sprouts, furnace top components, and water pipes. Feed chutes are oxidized, and thinned to a degree that raw mix charge leaked on the furnace top, leading to arcing and component failures. As a temporary measure, chutes are patched from time to time (Figure 16).

However, in worst-case scenario, chutes are replaced as and when required. To replace these chutes, the furnace needs to shut down for an extended period (10–12 hours) that is longer than for a normal shutdown (5 hours).
