**DAMAGE CAUSED BY THE EAST JAPAN EARTHQUAKE  
AND RECOVERY FROM THIS DISASTER  
AT THE KASHIMA WORKS, CHUO DENKI KOGYO CO., LTD**

**ABSTRACT**

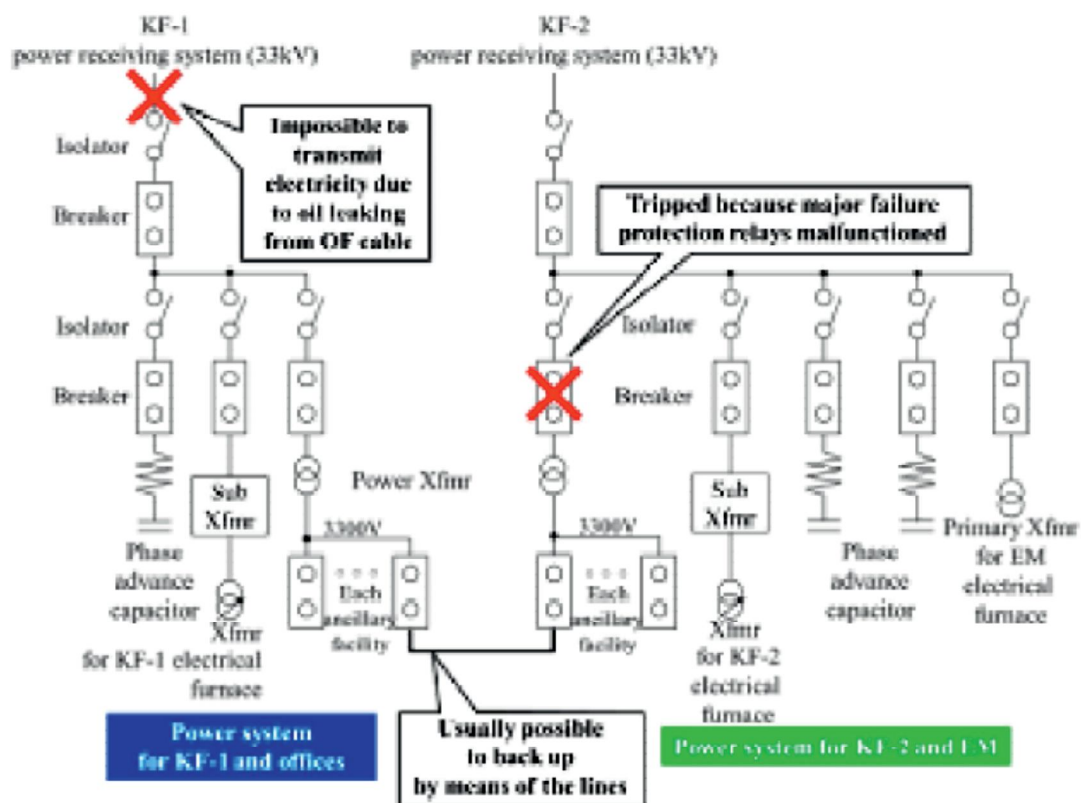
Figure 4.1.1: Power system diagram

Figure 4.1.1 shows the power system diagram for the Kashima works. We have two electrical lines which carry 33 kV to KF-1, KF-2 and EM. If one of these two lines is out of order, it can receive electricity via another high voltage line used for pumping cooling water and other purposes. The power transformer for KF-2 tripped because the induction disk relays (manufactured in 1973) malfunctioned as a result of the quake.

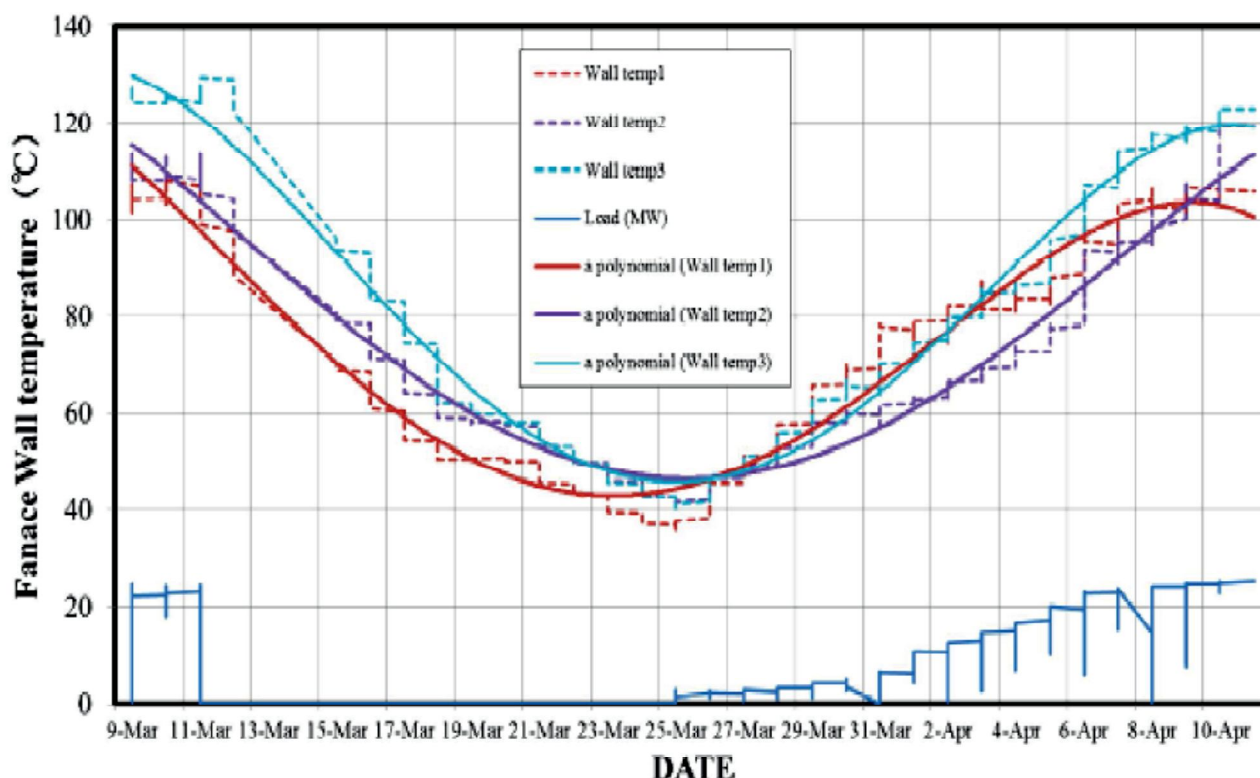
**Figure 4.5:** The relation of wall temperature and load

Figure 4.5 shows the process used to change the wall temperature in KF-1. KF-1 was initially able to receive electricity normally just after the disaster. However, on the day after the earthquake, we found dielectric oil leaking from the receiving cable and had to cut the electricity supply. As a result, we were unable to cool the furnace body normally using blowers.
